**Flood Control Project Maintenance
Levee Inspections**

Fall 2012 Levee Maintenance Deficiency Summary Report

Reclamation District No. 0900 West Sacramento

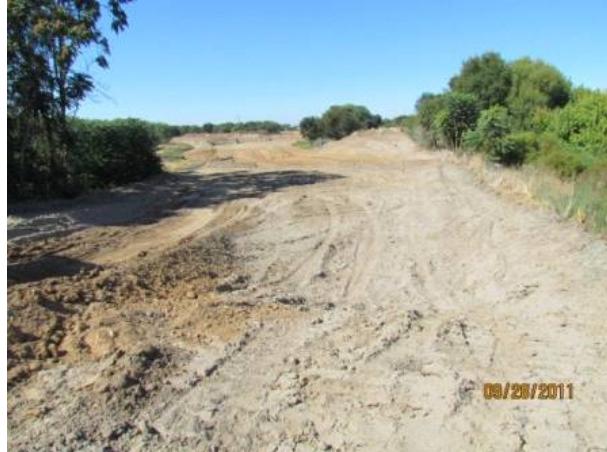
Levee Mile Report Line	8
Start Levee Mile	2.29
End Levee Mile	2.29
Location	Land Side
Category	Earthen Levee
Item	Slope Stability
Slope instability was caused due to vehicular traffic on the landside and crown of the levee looking upstream.	
pkazi_f_20120913_785.jpg

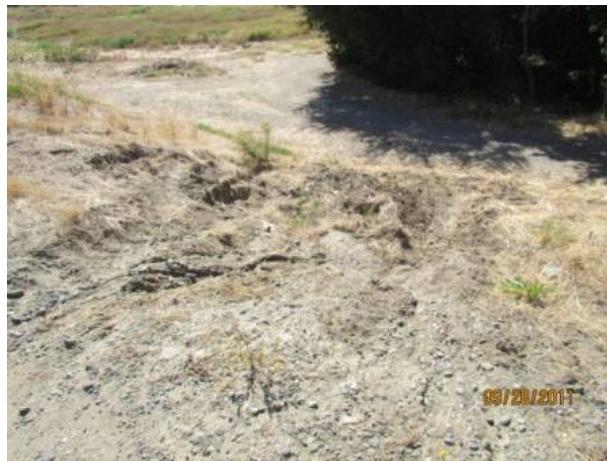
Levee Mile Report Line	8
Start Levee Mile	2.29
End Levee Mile	2.29
Location	Land Side
Category	Earthen Levee
Item	Slope Stability
Slope instability was found on the landside of the levee looking upstream.	
pkazi_f_20120913_786.jpg

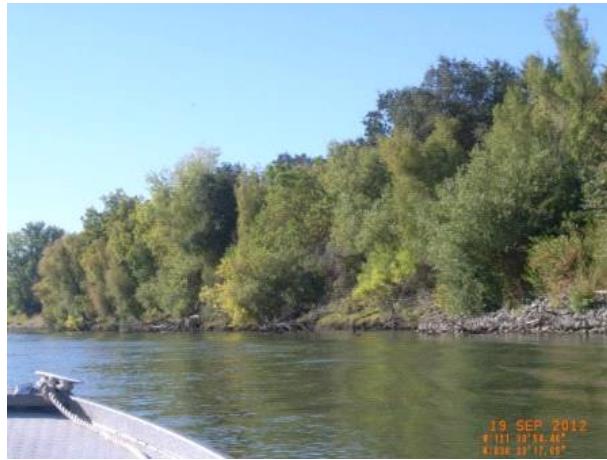
Levee Mile Report Line	11
Start Levee Mile	2.35
End Levee Mile	2.49
Location	Water Side
Category	Supplemental
Item	USACE Erosion Survey
USACE 2012 Photo #1	
USACE2012_SAC_56-7_R_1.jpg

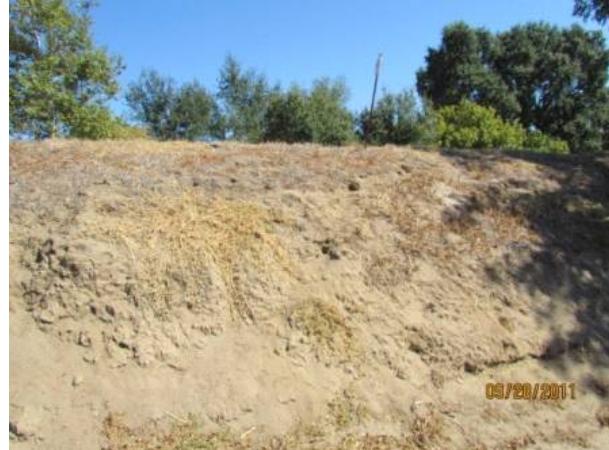
Levee Mile Report Line	19
Start Levee Mile	2.53
End Levee Mile	2.53
Location	Land Side
Category	Earthen Levee
Item	Animal Control
Rodent holes were found on the landside slope of the levee. The picture was taken from toe of the levee looking towards the crown.	
pkazi_f_20120913_783.jpg

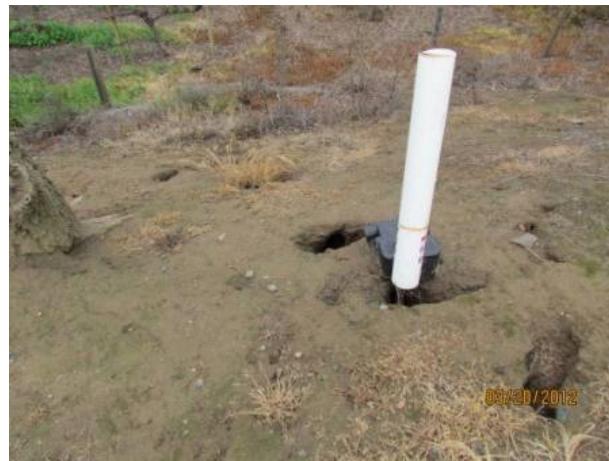
Levee Mile Report Line	19
Start Levee Mile	2.53
End Levee Mile	2.53
Location	Land Side
Category	Earthen Levee
Item	Animal Control
Rodent holes were found on the landside of the levee looking downstream. The picture was taken during spring 2012 inspection.	
pkazi_f_20120913_784.jpg

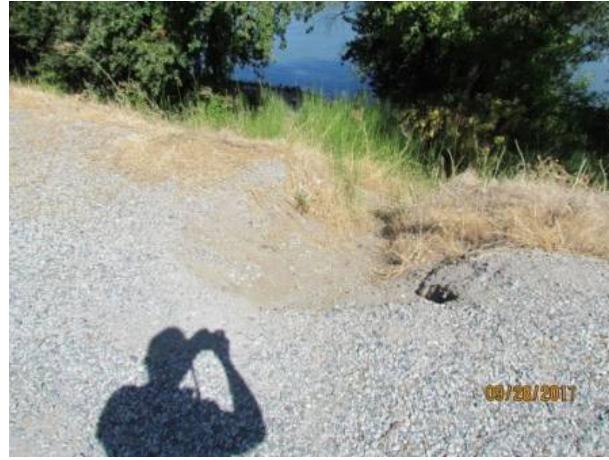
Levee Mile Report Line	20
Start Levee Mile	2.53
End Levee Mile	2.53
Location	Water Side
Category	Earthen Levee
Item	Slope Stability
Slope instability was found on the waterside of the levee looking upstream.	
pkazi_f_20120913_782.jpg

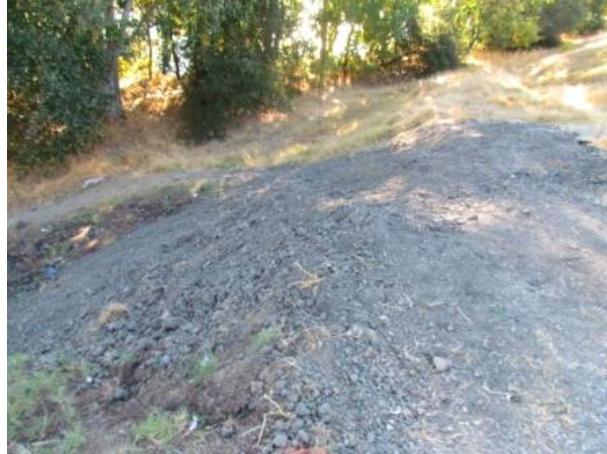
Levee Mile Report Line	27
Start Levee Mile	2.64
End Levee Mile	2.64
Location	Water Side
Category	Earthen Levee
Item	Slope Stability
Slope instability issue is fixed by the LMA on the waterside shoulder of the levee looking downstream.	
pkazi_f_20121019_960.jpg

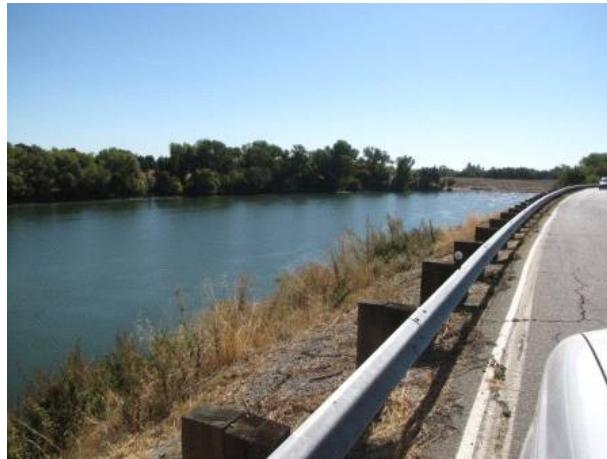
Levee Mile Report Line	29
Start Levee Mile	2.90
End Levee Mile	2.90
Location	Water Side
Category	Earthen Levee
Item	Vegetation
View of vegetation within the top 20' of the waterward slope looking downstream.	
pkazi_f_20120913_771.jpg

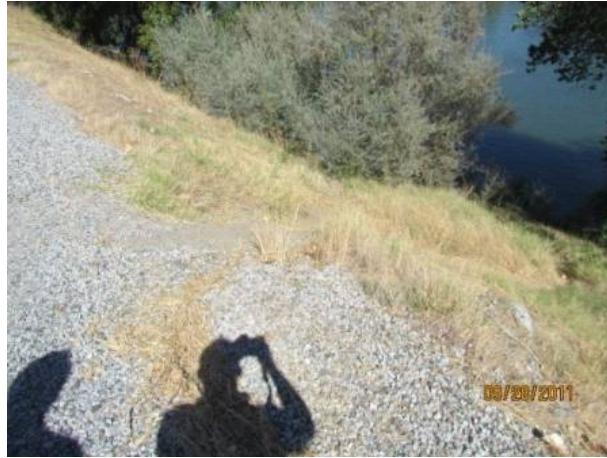
Levee Mile Report Line	30
Start Levee Mile	3.02
End Levee Mile	3.02
Location	Water Side
Category	Earthen Levee
Item	Slope Stability
Slope instability was found due to foot traffic on the waterside of the slope looking upstream.	
pkazi_f_20120913_779.jpg

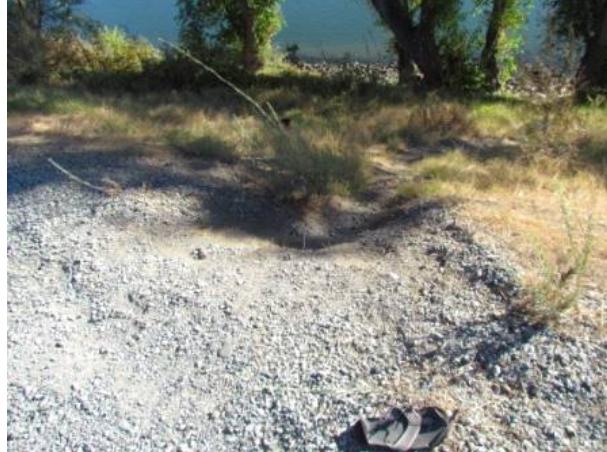
Levee Mile Report Line	30
Start Levee Mile	3.02
End Levee Mile	3.02
Location	Water Side
Category	Earthen Levee
Item	Slope Stability
Updated pictures of slope instability on the waterside of the levee looking upstream during fall 2012 inspection.	
pkazi_f_20121019_961.jpg

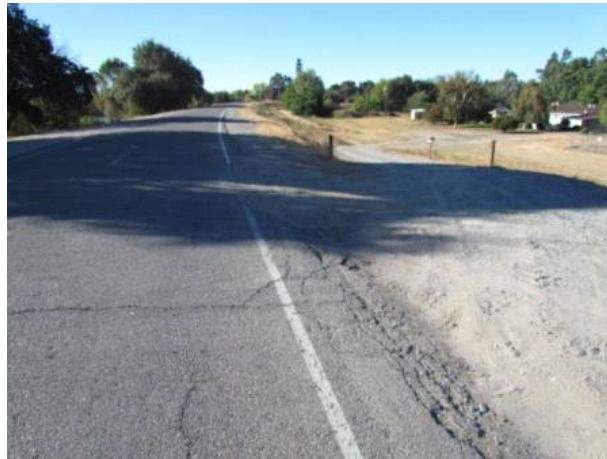
Levee Mile Report Line	31
Start Levee Mile	3.14
End Levee Mile	3.14
Location	Land Side
Category	Earthen Levee
Item	Slope Stability
Crown depression and side curb was repaired by the LMA. The picture was taken from the crown looking downstream.	
pkazi_f_20121019_962.jpg

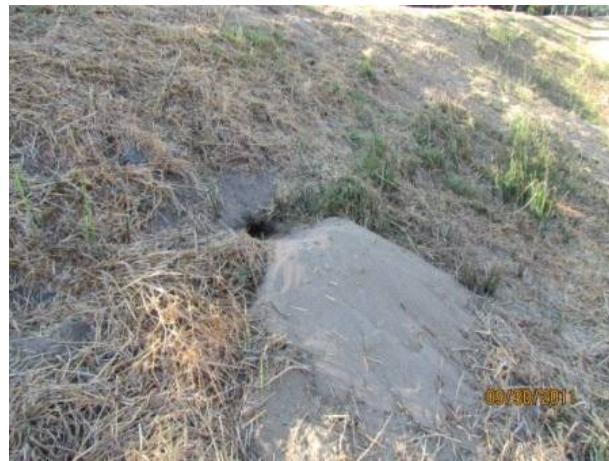
Levee Mile Report Line	37
Start Levee Mile	3.43
End Levee Mile	3.43
Location	Land Side
Category	Earthen Levee
Item	Animal Control
Rodent hole was found landside of the levee looking upstream.	
pkazi_f_20120913_788.jpg

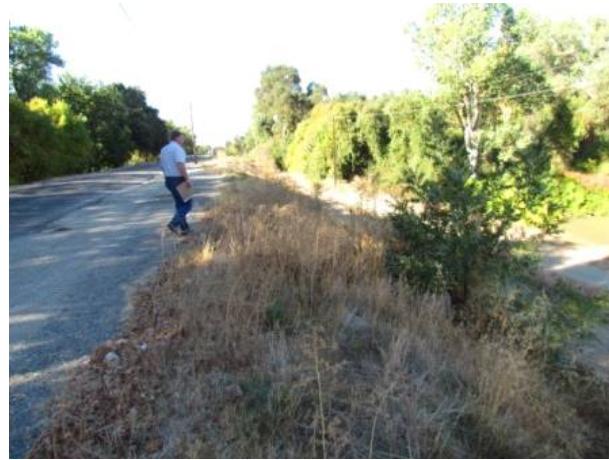
Levee Mile Report Line	43
Start Levee Mile	3.93
End Levee Mile	5.86
Location	Land Side
Category	Earthen Levee
Item	Vegetation
Overgrown vegetation was found on the landside of the levee looking downstream.	
pkazi_f_20121019_963.jpg

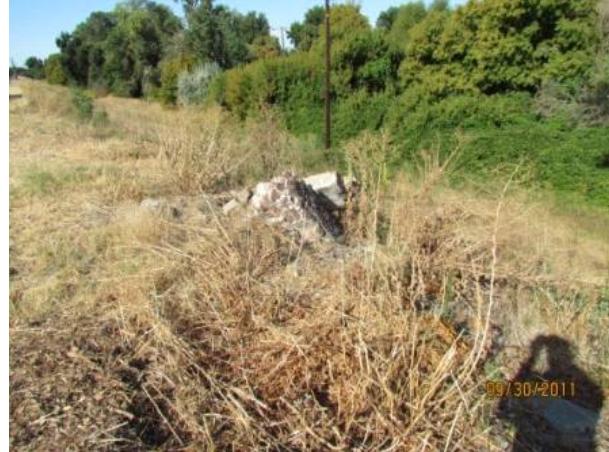
Levee Mile Report Line	45
Start Levee Mile	4.05
End Levee Mile	4.05
Location	Land Side
Category	Earthen Levee
Item	Encroachments
Concrete debris were found on the landside of the levee looking upstream.	
pkazi_f_20120913_789.jpg

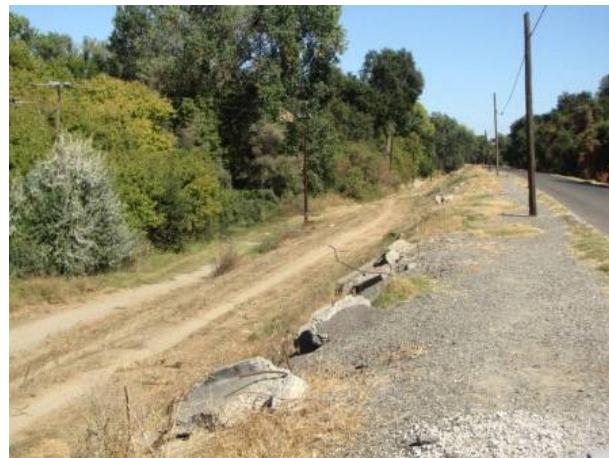
46	4.11	4.11	Earthen Levee	Encroachments	LS M Ma	DE : Debris	38.534364 ° -121.526051 °	38.534364 ° -121.526051 °	54		
						Inspector Comments: Concrete debris with metal posing a safety risk.				DWR ID: DWR_RD0900_01_s_2012_54	
47	4.12	4.12	Earthen Levee	Encroachments	LS M Ma	DE : Debris	38.534358 ° -121.525947 °	38.534358 ° -121.525947 °	328		
										DWR ID: DWR_RD0900_01_s_2012_328	
48	4.12	4.12	Earthen Levee	Slope Stability	LS M Ma	S3 : Repair the levee slope damaged by vehicle traffic and prevent access where possible.	38.534354 ° -121.525943 °	38.534354 ° -121.525943 °	329		
										DWR ID: DWR_RD0900_01_s_2012_329	
49	4.28	4.28	Earthen Levee	Encroachments	WS U En	BU : Building	38.533274 ° -121.528628 °	38.533274 ° -121.528628 °	20		
						Inspector Comments: Miscellaneous unpermitted encroachments at the Sherwood Harbor. An encroachment permit application is being reviewed by RD900.				DWR ID: DWR_RD0900_01_s_2012_20

Levee Mile Report Line	46
Start Levee Mile	4.11
End Levee Mile	4.11
Location	Land Side
Category	Earthen Levee
Item	Encroachments
View of concrete debris with metal looking upstream.	
pkazi_f_20120913_778.jpg

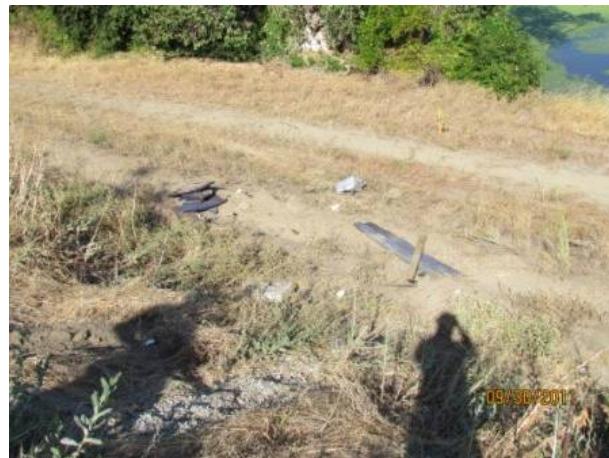
Levee Mile Report Line	47
Start Levee Mile	4.12
End Levee Mile	4.12
Location	Land Side
Category	Earthen Levee
Item	Encroachments
Debris were found on the landside toe of the levee. The picture was taken from the crown looking towards the toe.	
pkazi_f_20120913_790.jpg

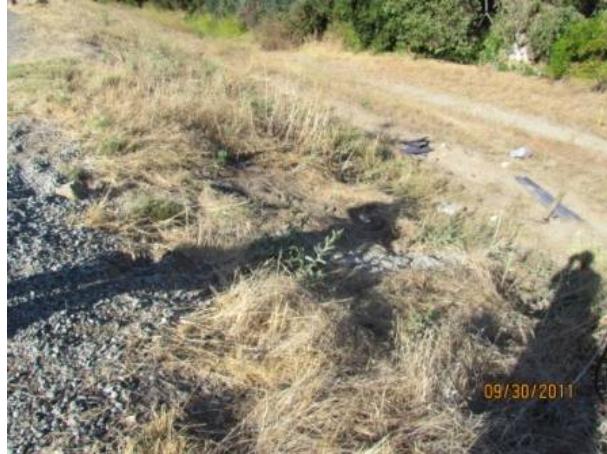
Levee Mile Report Line	48
Start Levee Mile	4.12
End Levee Mile	4.12
Location	Land Side
Category	Earthen Levee
Item	Slope Stability
Slope instability was caused by vehicular traffic on the landside slope of the levee. The picture was taken from the crown looking upstream.	
pkazi_f_20120913_791.jpg

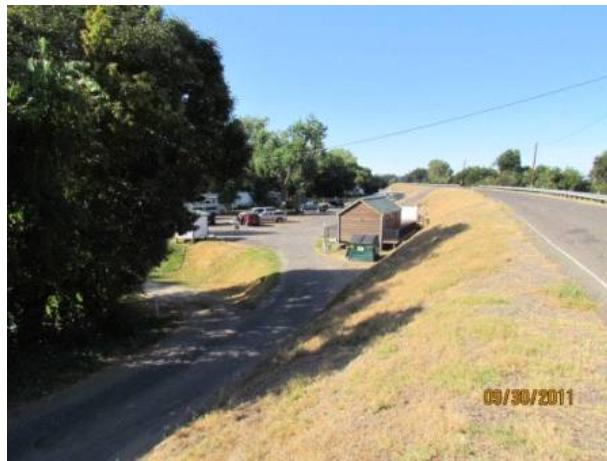
Levee Mile Report Line	49
Start Levee Mile	4.28
End Levee Mile	4.28
Location	Water Side
Category	Earthen Levee
Item	Encroachments
View of Sherwood harbor's unpermitted properties on the waterside of the levee. The picture was taken from the crown looking upstream.	
pkazi_f_20120913_772.jpg

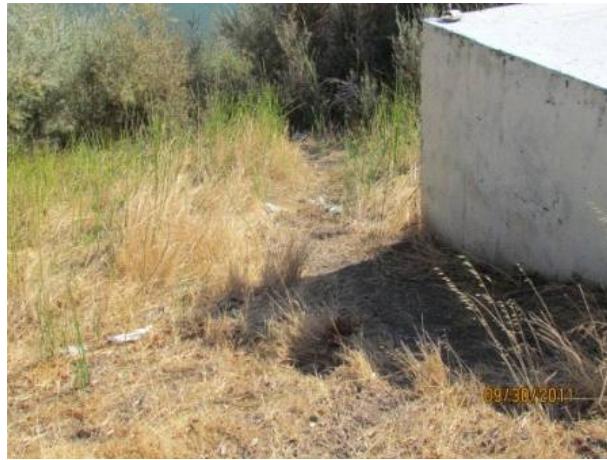
Levee Mile Report Line	53
Start Levee Mile	4.97
End Levee Mile	4.97
Location	Water Side
Category	Earthen Levee
Item	Slope Stability
Slope instability was caused by foot traffic on the waterside slope of the levee looking upstream.	
pkazi_f_20120913_793.jpg

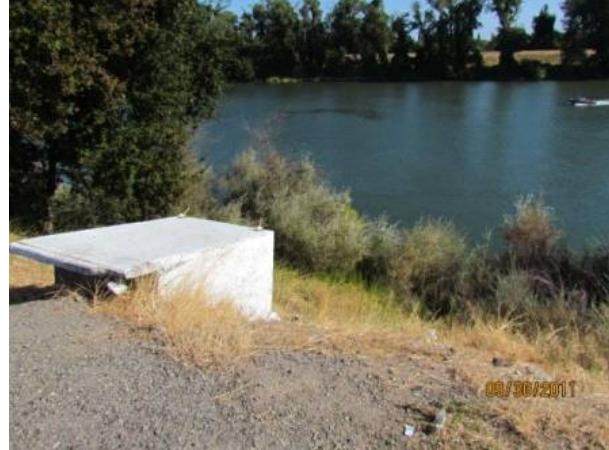
Levee Mile Report Line	54
Start Levee Mile	4.97
End Levee Mile	4.97
Location	Water Side
Category	Earthen Levee
Item	Encroachments
Concrete anchor was found on the waterside slope of the levee looking upstream.	
pkazi_f_20120913_792.jpg

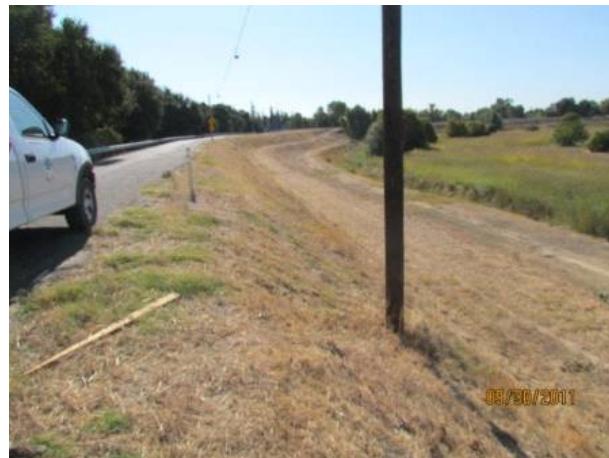
Levee Mile Report Line	56
Start Levee Mile	5.20
End Levee Mile	5.20
Location	Land Side
Category	Earthen Levee
Item	Encroachments
View of the pole on the landside of the levee looking upstream.	
pkazi_f_20120913_794.jpg

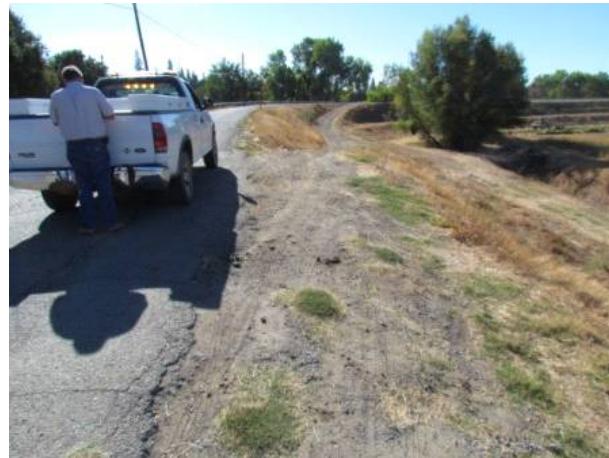
Levee Mile Report Line	60
Start Levee Mile	5.30
End Levee Mile	5.30
Location	Land Side
Category	Earthen Levee
Item	Crown Surface / Depressions / Rutting
Depression on the landside shoulder of the levee was repaired by the LMA looking downstream.	
pkazi_f_20121019_964.jpg

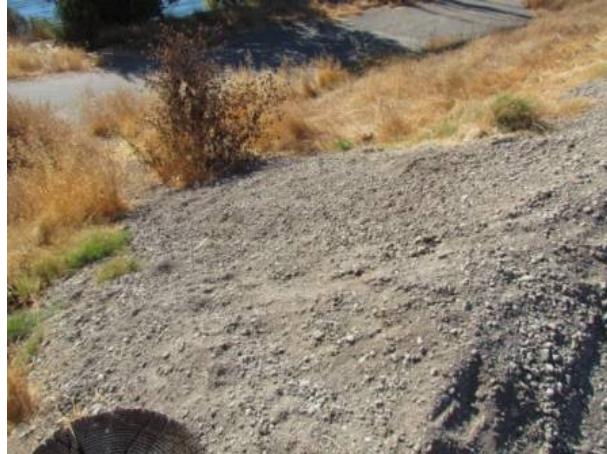
Levee Mile Report Line	61
Start Levee Mile	5.37
End Levee Mile	5.37
Location	Water Side
Category	Earthen Levee
Item	Slope Stability
Slope instability issue was repaired by the LMA on the waterside of the levee looking downstream.	
pkazi_f_20121019_965.jpg

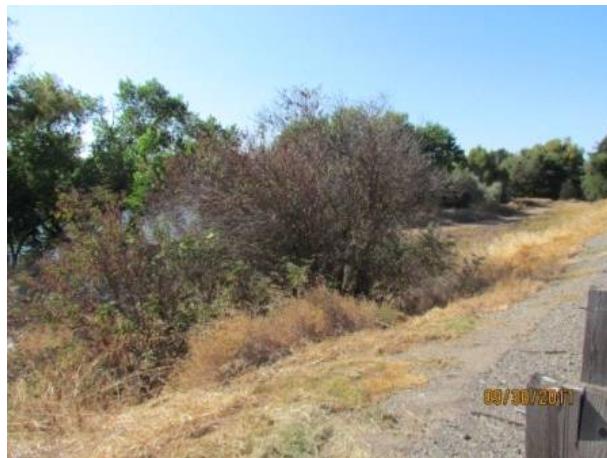
Levee Mile Report Line	65
Start Levee Mile	5.40
End Levee Mile	5.40
Location	Water Side
Category	Earthen Levee
Item	Vegetation
View of elderberry bush on the waterside of the levee looking upstream.	
pkazi_f_20120913_796.jpg

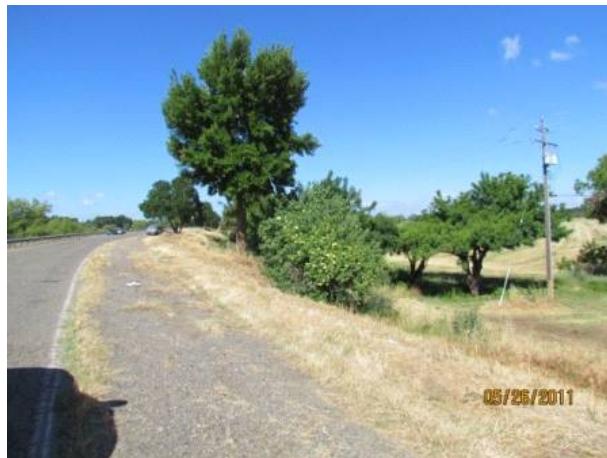
Levee Mile Report Line	66
Start Levee Mile	5.53
End Levee Mile	5.53
Location	Land Side
Category	Earthen Levee
Item	Vegetation
Elderberry on the landside of the levee. The picture was taken from the crown looking downstream.	
pkazi_f_20120913_803.jpg

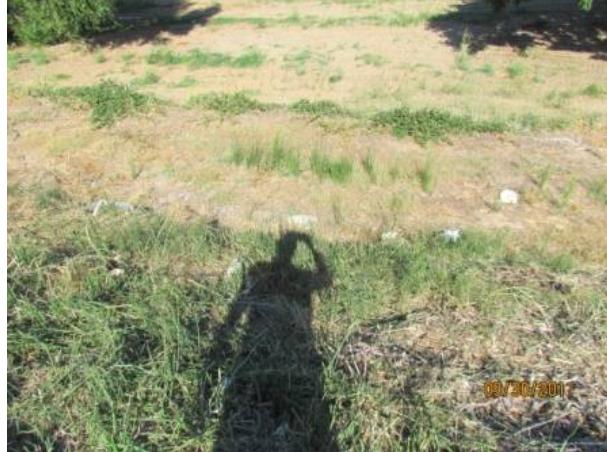
Levee Mile Report Line	68
Start Levee Mile	5.57
End Levee Mile	5.57
Location	Land Side
Category	Earthen Levee
Item	Encroachments
Debris were found on the landside of the levee. The picture was taken from the crown looking towards the toe.	
pkazi_f_20120913_797.jpg

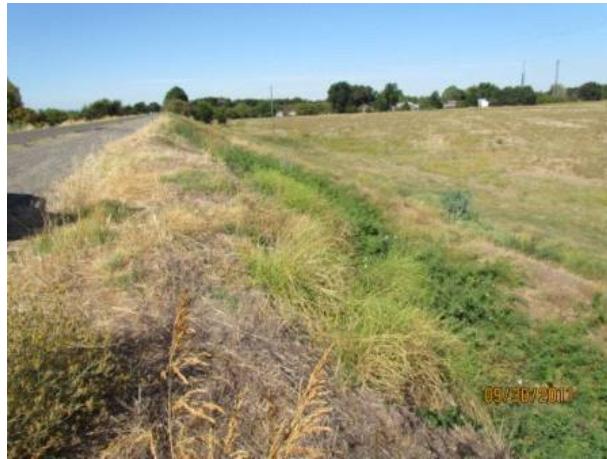
Levee Mile Report Line	72
Start Levee Mile	5.86
End Levee Mile	6.83
Location	Land Side
Category	Earthen Levee
Item	Vegetation
Wild growth was found on the landside of the levee looking upstream.	
pkazi_f_20120913_801.jpg

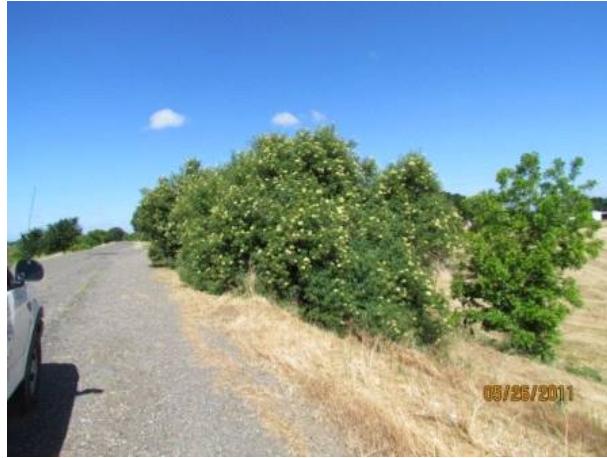
Levee Mile Report Line	73
Start Levee Mile	5.97
End Levee Mile	5.98
Location	Land Side
Category	Earthen Levee
Item	Vegetation
Elderberry located on the landside of the levee obstructing the view. The picture was taken from the crown looking downstream.	
pkazi_f_20120913_774.jpg

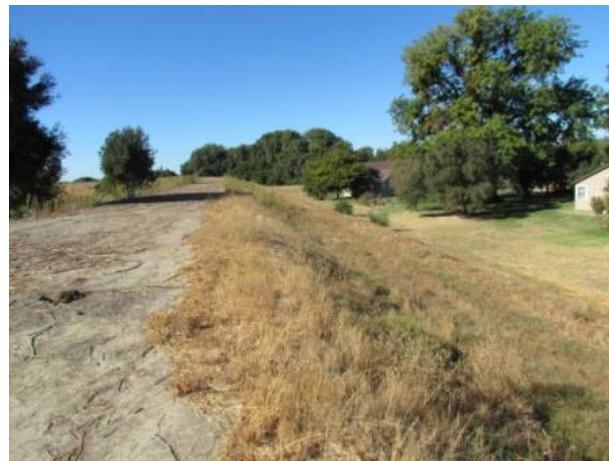
Levee Mile Report Line	76
Start Levee Mile	6.85
End Levee Mile	7.80
Location	Land Side
Category	Earthen Levee
Item	Vegetation
Vegetation was found on the landside of the levee looking downstream.	
pkazi_f_20121019_966.jpg

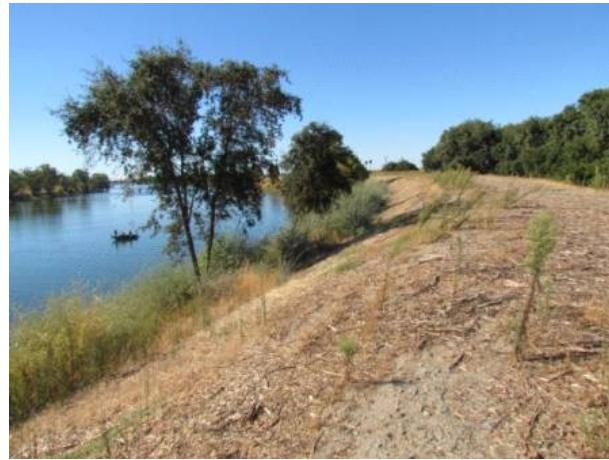
Levee Mile Report Line	77
Start Levee Mile	6.85
End Levee Mile	7.80
Location	Water Side
Category	Earthen Levee
Item	Vegetation
Vegetation was found on the waterside slope of the levee looking downstream.	
pkazi_f_20121019_967.jpg

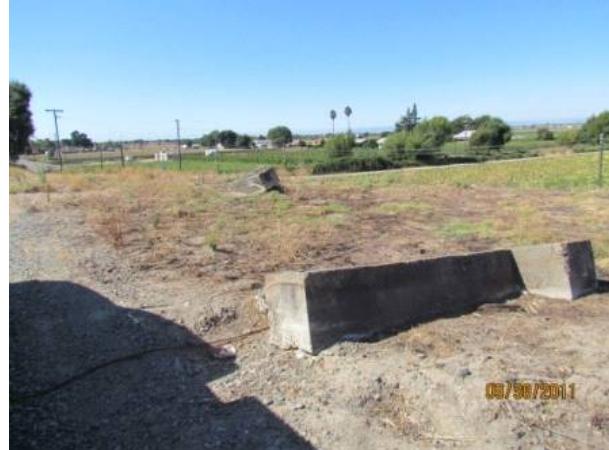
Levee Mile Report Line	78
Start Levee Mile	7.12
End Levee Mile	7.12
Location	Land Side
Category	Earthen Levee
Item	Encroachments
Concrete debris from old rail road track was found on the landside of the levee looking upstream.	
pkazi_f_20120913_802.jpg

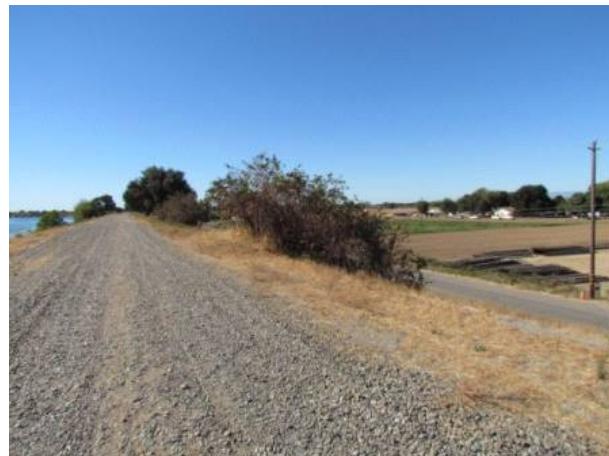
Levee Mile Report Line	79
Start Levee Mile	7.23
End Levee Mile	7.23
Location	Land Side
Category	Earthen Levee
Item	Vegetation
Elderberry tree was found on the landside of the levee looking downstream.	
pkazi_f_20121019_968.jpg

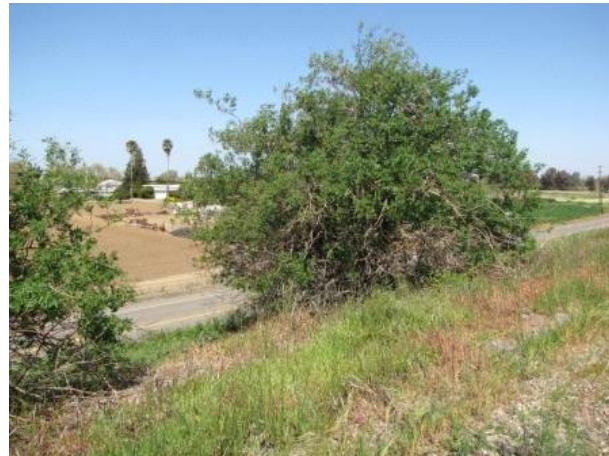
Levee Mile Report Line	80
Start Levee Mile	7.27
End Levee Mile	7.27
Location	Land Side
Category	Earthen Levee
Item	Vegetation
View of elderberries blocking visibility on the landward slope looking upstream.	
pkazi_f_20120913_766.jpg

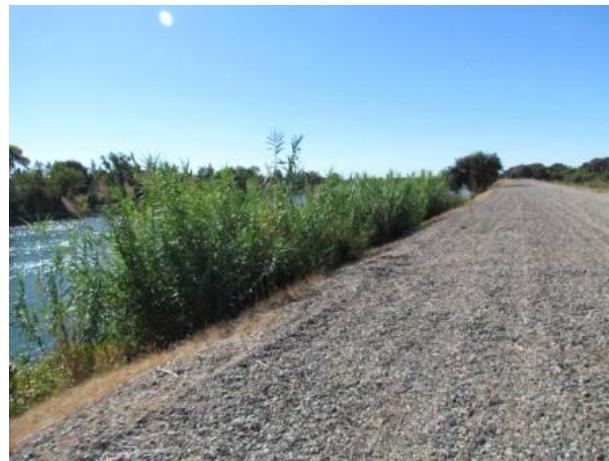
Levee Mile Report Line	82
Start Levee Mile	7.49
End Levee Mile	7.49
Location	Water Side
Category	Earthen Levee
Item	Vegetation
View of Arundo on the waterside slope of the levee looking downstream.	
pkazi_f_20121019_969.jpg

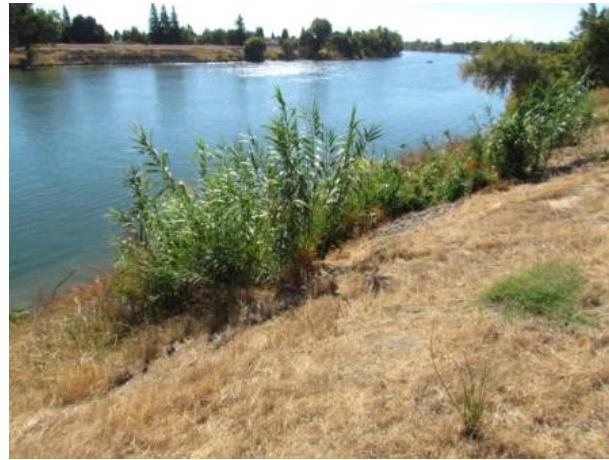
Levee Mile Report Line	83
Start Levee Mile	7.80
End Levee Mile	7.80
Location	Water Side
Category	Earthen Levee
Item	Vegetation
View of Arundo on the waterside slope of the levee looking downstream.	
pkazi_f_20121019_970.jpg

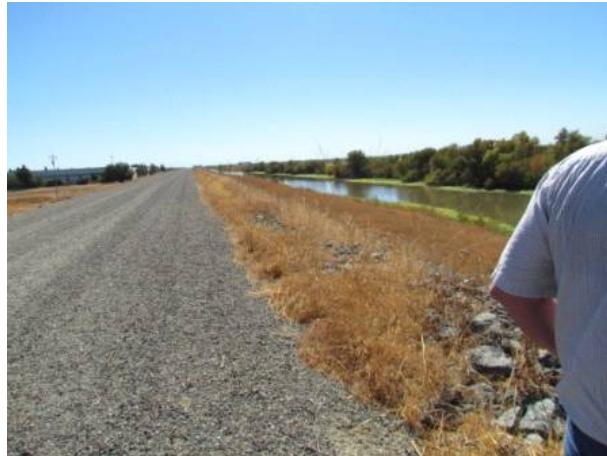
Levee Mile Report Line	5
Start Levee Mile	1.19
End Levee Mile	2.07
Location	Water Side
Category	Earthen Levee
Item	Vegetation
Vegetation was found on the waterside of the levee looking downstream.	
pkazi_f_20121019_979.jpg

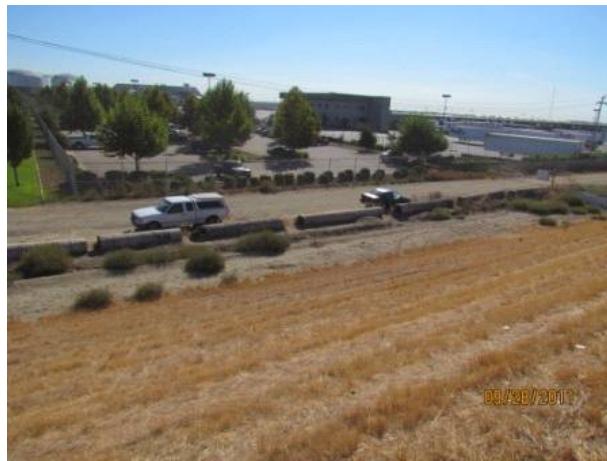
Levee Mile Report Line	8
Start Levee Mile	2.07
End Levee Mile	2.07
Location	Water Side
Category	Earthen Levee
Item	Encroachments
Pipes were placed at the toe of the landside of the levee to prevent people from driving on the slope. The picture was taken from the crown looking upstream.	
pkazi_f_20120913_808.jpg

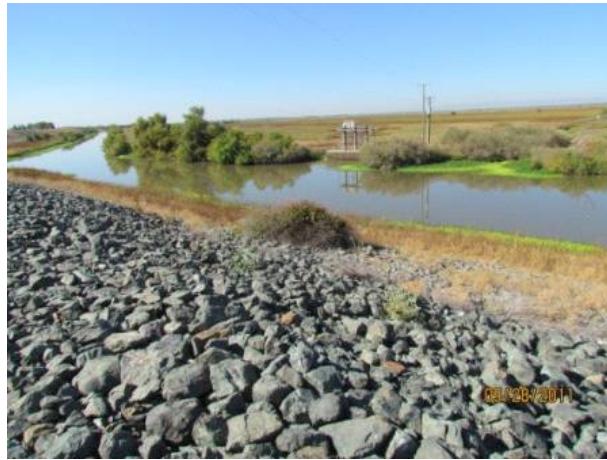
Levee Mile Report Line	9
Start Levee Mile	2.45
End Levee Mile	2.45
Location	Water Side
Category	Earthen Levee
Item	Vegetation
Prunings were found on the waterside of the levee looking upstream.	
pkazi_f_20120913_812.jpg

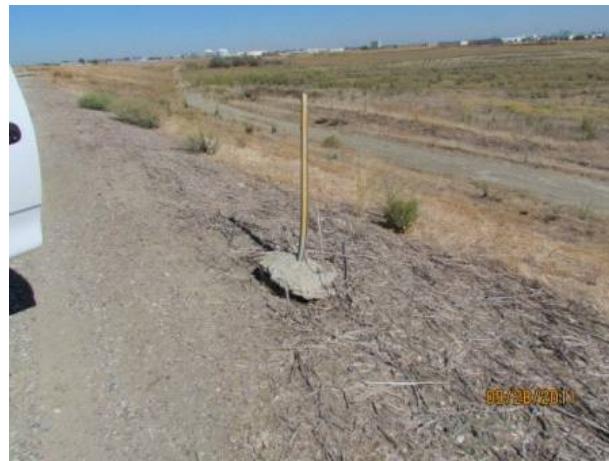
Levee Mile Report Line	11
Start Levee Mile	3.12
End Levee Mile	3.12
Location	Land Side
Category	Earthen Levee
Item	Encroachments
Abandon pole was found on the landside of the levee looking upstream.	pkazi_f_20120913_813.jpg

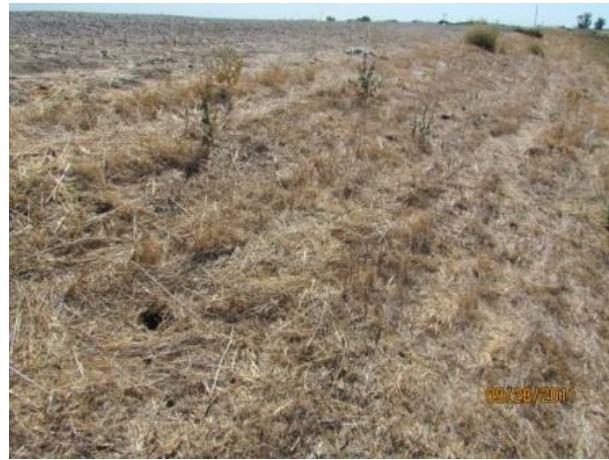
Levee Mile Report Line	12
Start Levee Mile	3.12
End Levee Mile	3.12
Location	Water Side
Category	Earthen Levee
Item	Animal Control
A rodent hole was found on the waterside of the levee. The picture was taken from toe of the levee looking upstream.	pkazi_f_20120913_814.jpg

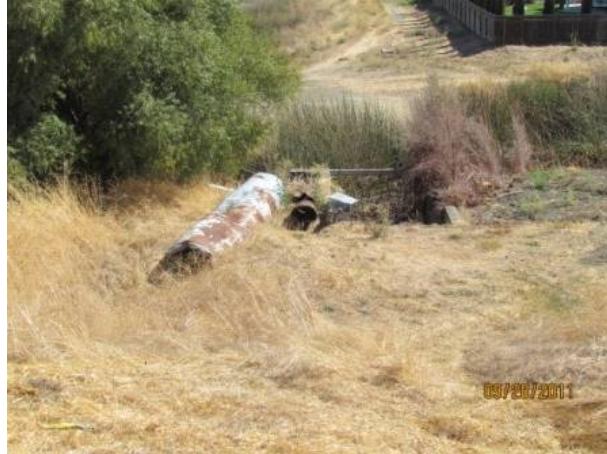
Levee Mile Report Line	15
Start Levee Mile	3.26
End Levee Mile	3.26
Location	Land Side
Category	Earthen Levee
Item	Encroachments
Abandon pipes and debris was found on the landside of the levee looking upstream.	
pkazi_f_20120913_810.jpg

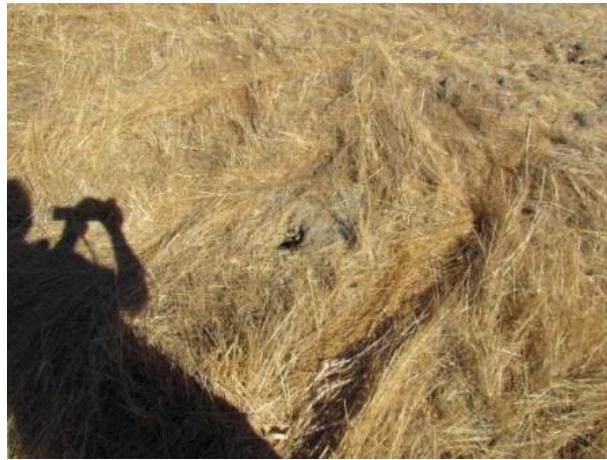
Levee Mile Report Line	17
Start Levee Mile	3.30
End Levee Mile	3.30
Location	Land Side
Category	Earthen Levee
Item	Animal Control
Animal burrow was found on the landside of the levee looking downstream.	
pkazi_f_20121019_975.jpg

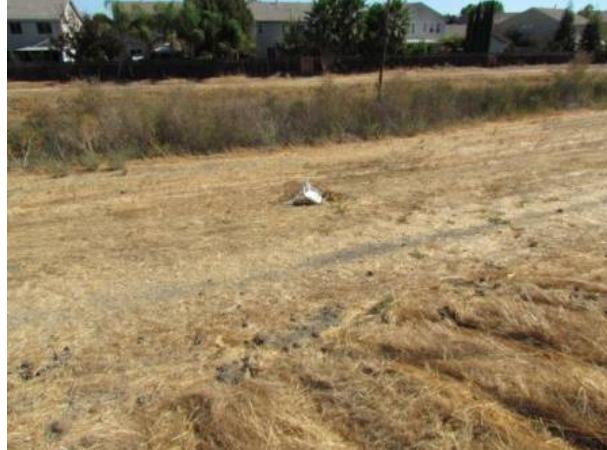
Levee Mile Report Line	18
Start Levee Mile	3.30
End Levee Mile	3.30
Location	Land Side
Category	Earthen Levee
Item	Encroachments
Debris was found on the landside of the levee looking downstream.	
<i>pkazi_f_20121019_976.jpg</i>

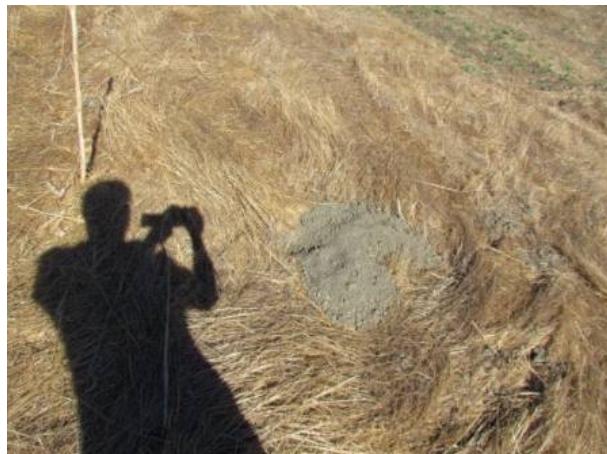
Levee Mile Report Line	19
Start Levee Mile	3.42
End Levee Mile	3.42
Location	Land Side
Category	Earthen Levee
Item	Animal Control
Animal borrow was found on the landside of the levee looking upstream.	
<i>pkazi_f_20121019_977.jpg</i>

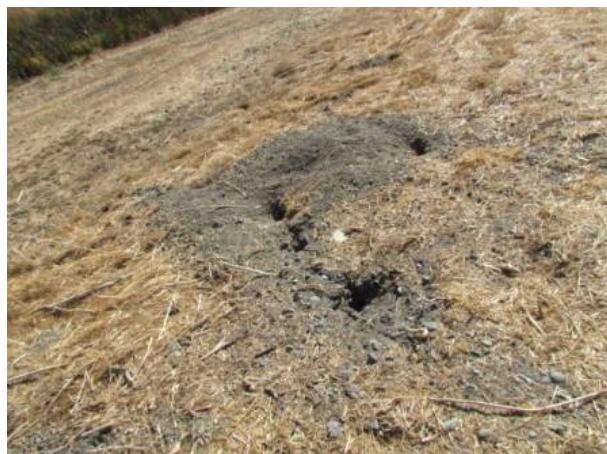
Levee Mile Report Line	20
Start Levee Mile	3.48
End Levee Mile	3.48
Location	Land Side
Category	Earthen Levee
Item	Animal Control
Animal holes were found on the landside of the levee looking downstream.	
<i>pkazi_f_20121019_978.jpg</i>

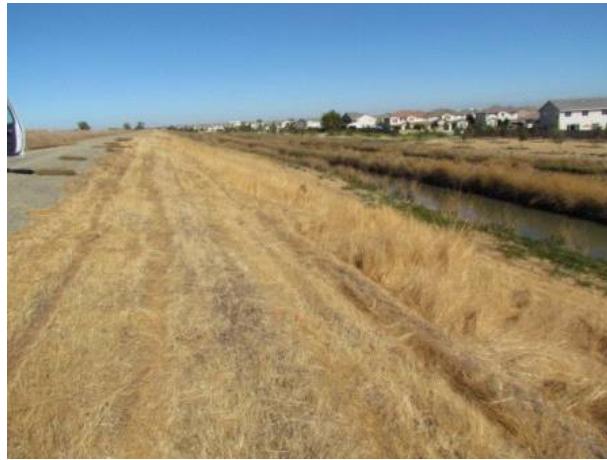
Levee Mile Report Line	25
Start Levee Mile	3.97
End Levee Mile	4.49
Location	Land Side
Category	Earthen Levee
Item	Vegetation
View of the vegetation on the landside slope of the levee looking upstream.	
pkazi_f_20121019_973.jpg

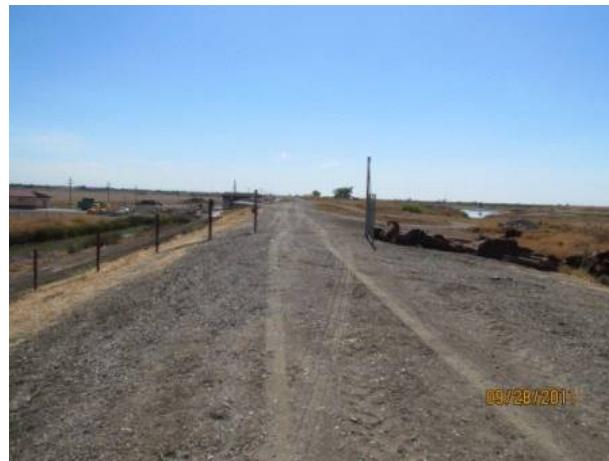
Levee Mile Report Line	27
Start Levee Mile	4.85
End Levee Mile	4.85
Location	Crown
Category	Earthen Levee
Item	Encroachments
A gate is installed by the LMA on the crown of the levee looking upstream.	
pkazi_f_20120913_819.jpg

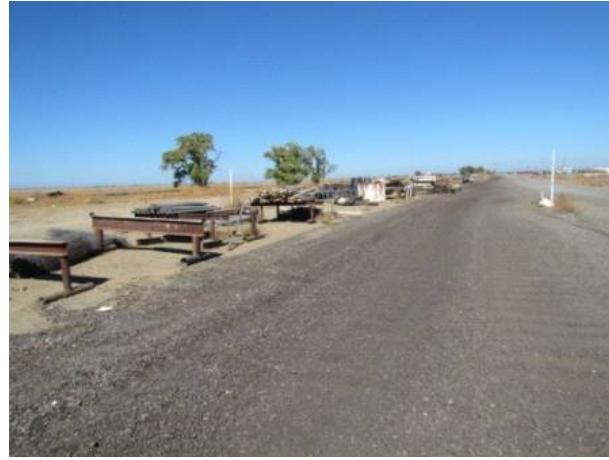
Levee Mile Report Line	36
Start Levee Mile	5.32
End Levee Mile	5.32
Location	Water Side
Category	Earthen Levee
Item	Encroachments
View of the equipments on the waterside shoulder of the levee looking upstream.	
pkazi_f_20121019_971.jpg
